# ***Improving Access to Safe Water: Perspectives from Africa and the Americas***

**Ernesto J. González**

## Study case: La Mariposa reservoir

## Study case: Pao-Cachinche reservoir

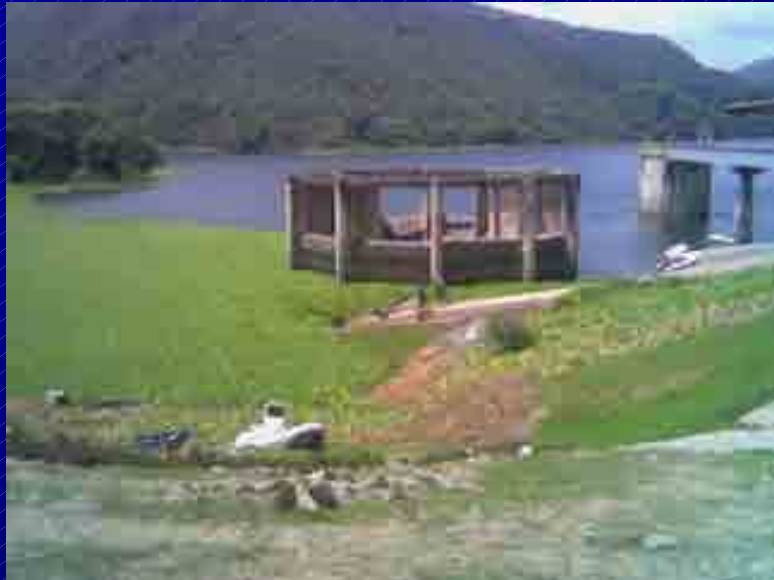
May 2006: ~10% covered

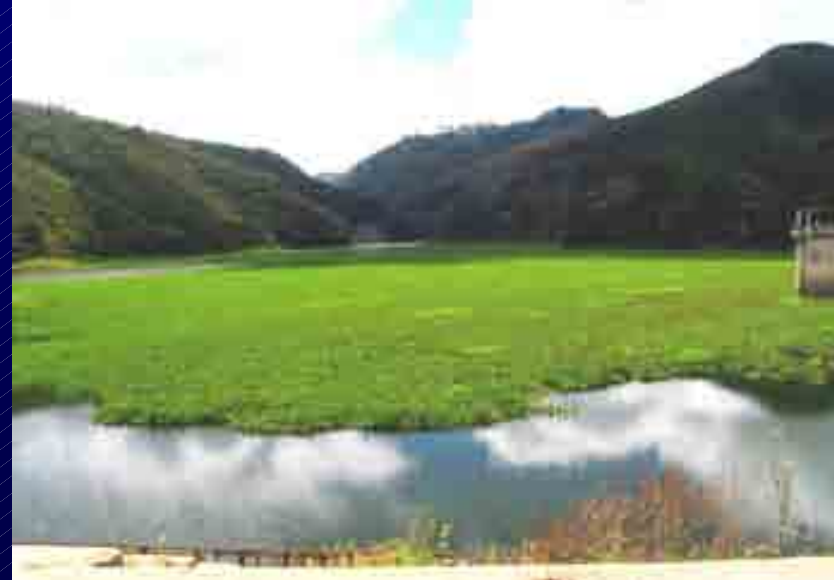
February 2007: ~85% covered

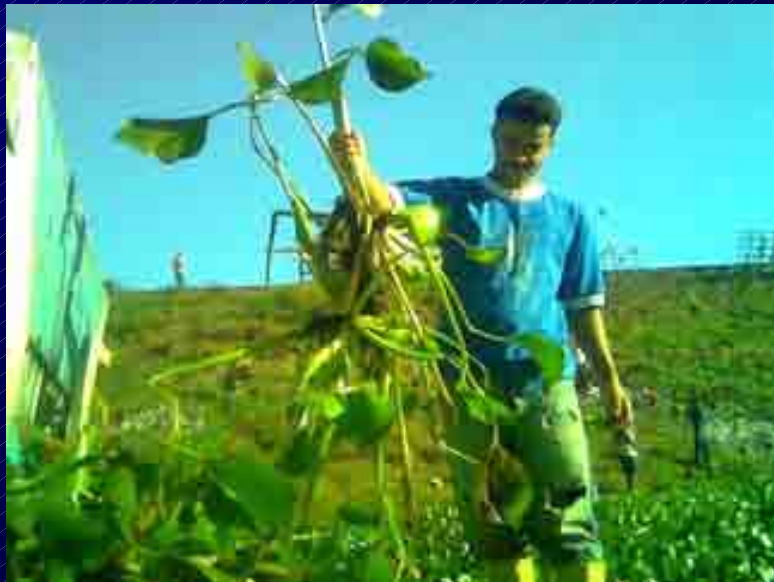
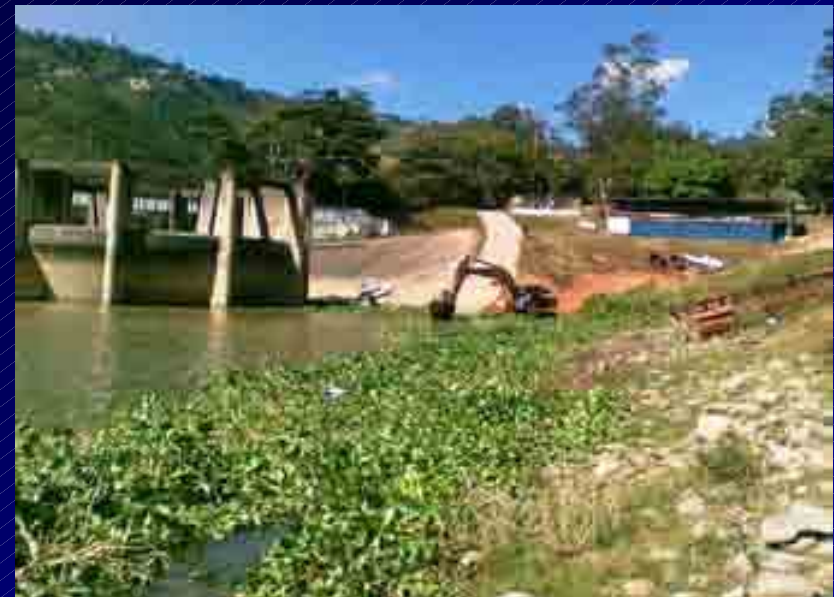
Mechanical harvesting was used to control this macrophyte

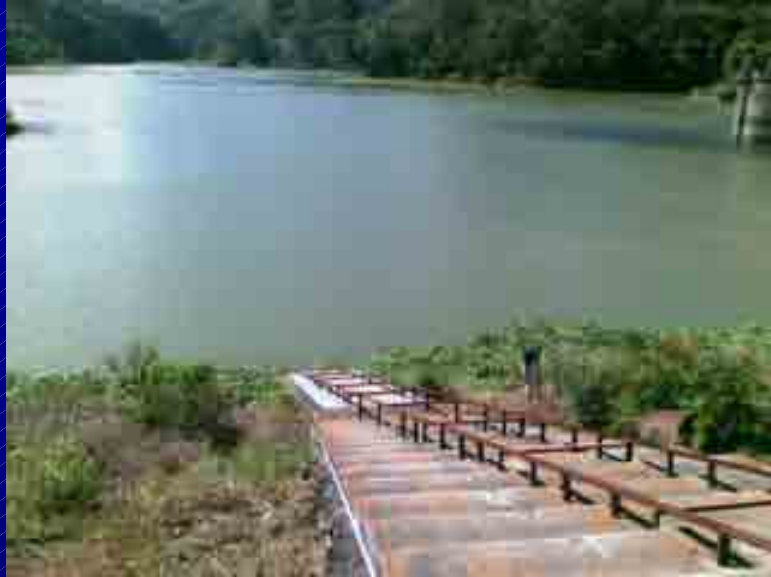
January 2008: Macrophyte removed

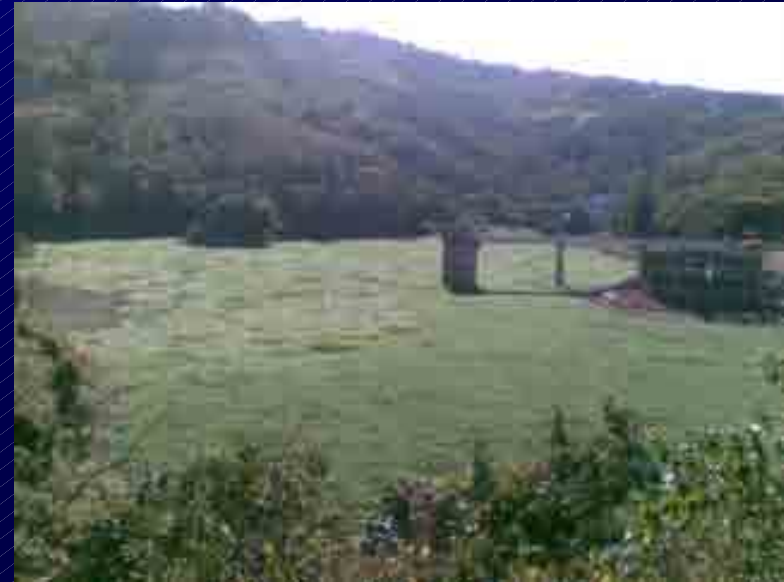
January 2009: ~ 50% covered

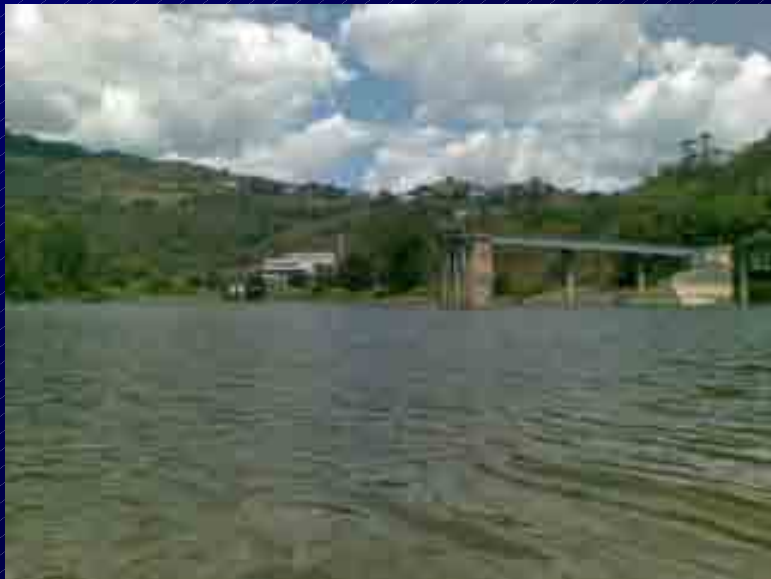
April 2009: Macrophyte removed

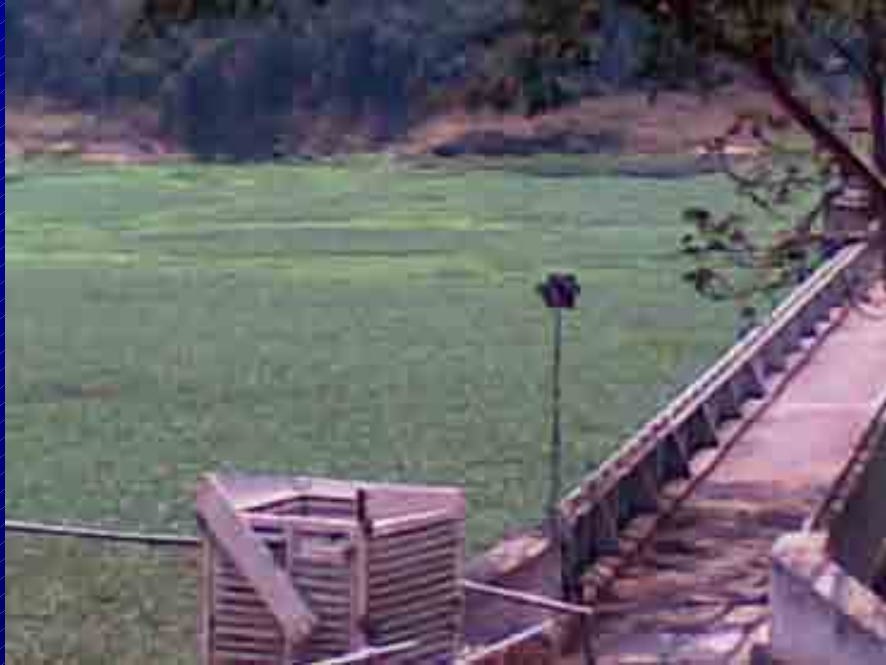
More than 90% of reservoir surface was covered by *E. crassipes*... again...

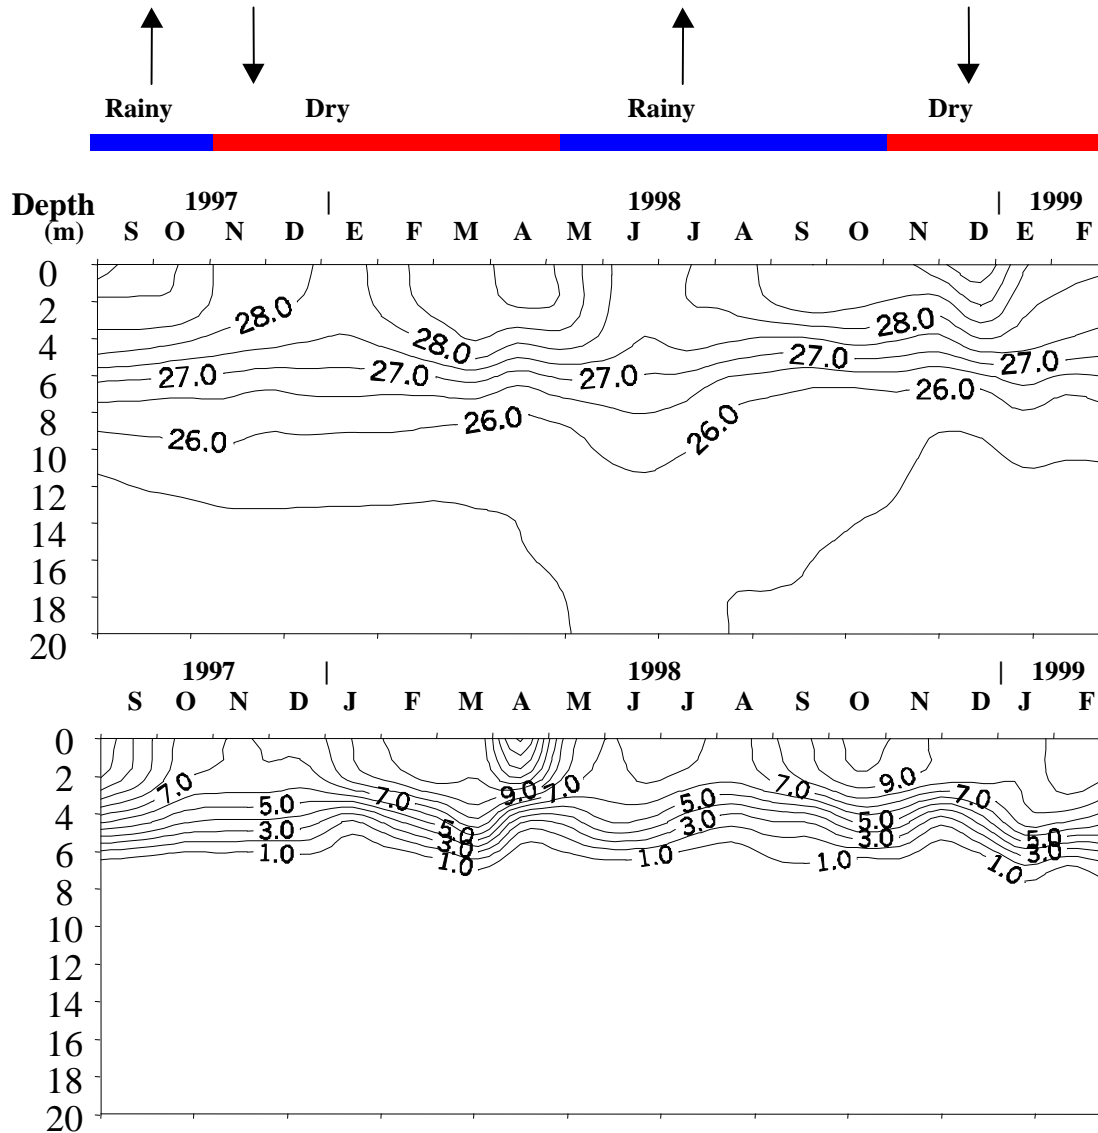
# Before aeration

Temperature  
(°C)

Dissolved  
oxygen  
(mg/l)

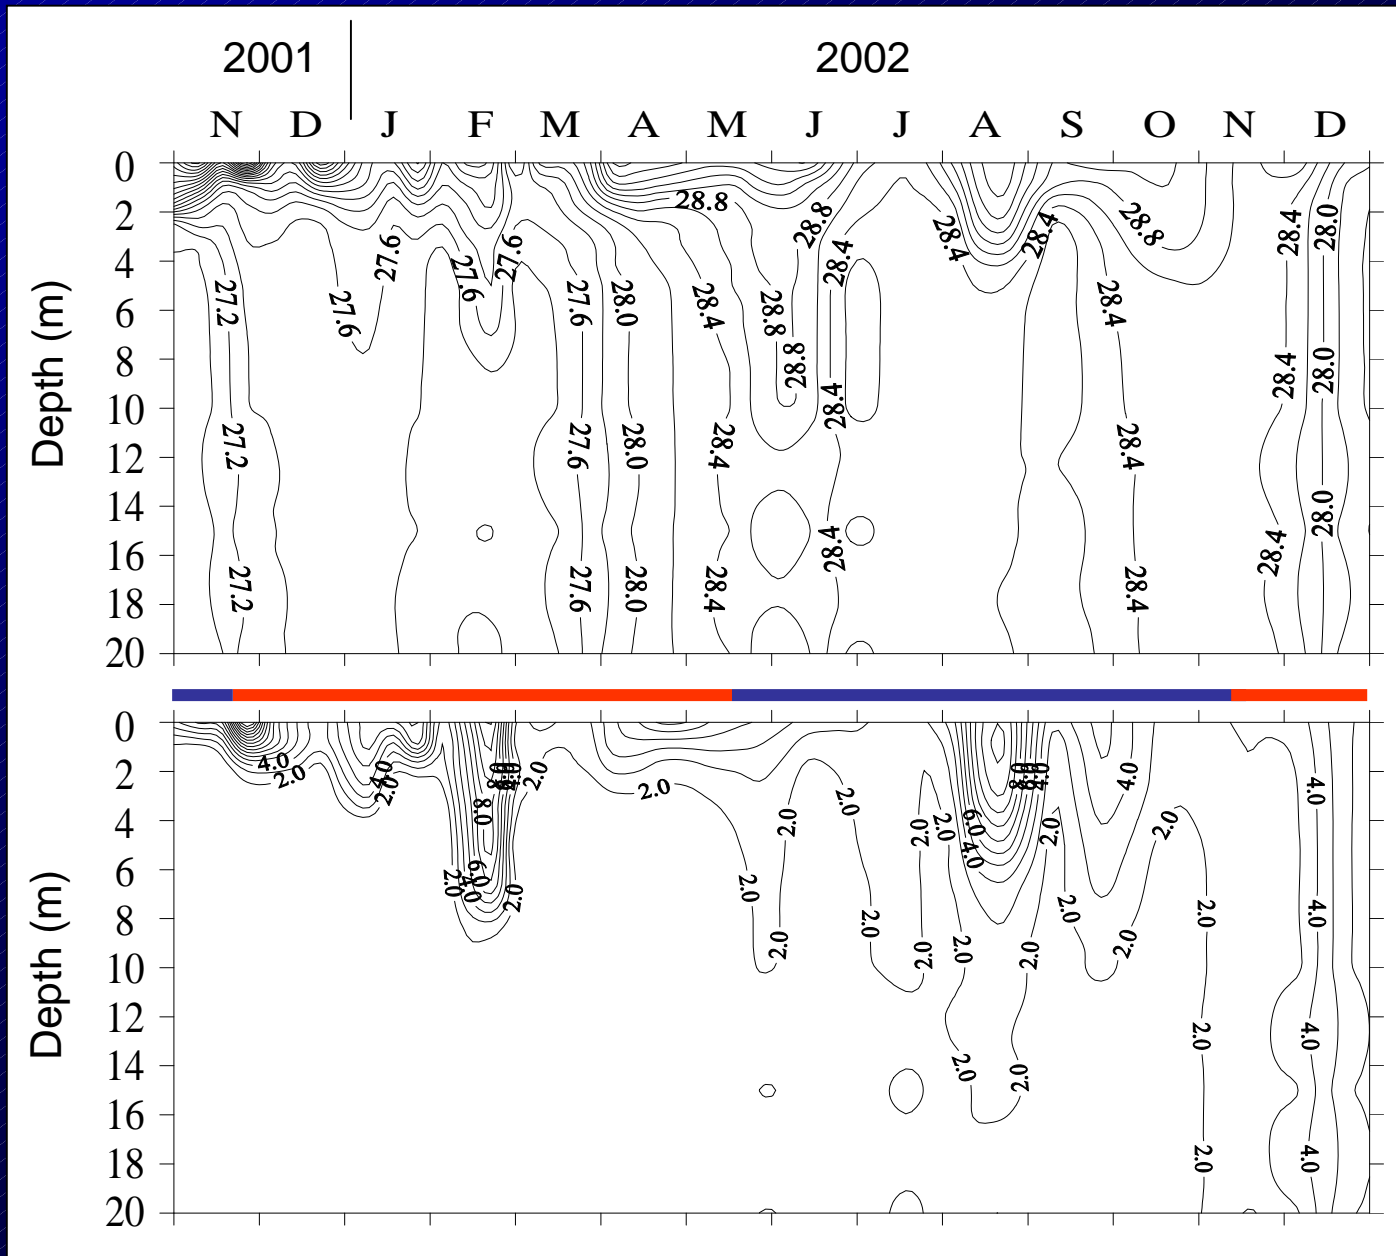
# After aeration

Temperature (°C)

Dissolved oxygen (mg/l)

- Increase of water transparency.
- Gradual loss of thermal stratification.
- Decrease of epilimnetic dissolved oxygen concentrations as compared with the previous supersaturated values, and hypolimnetic oxygenation.
- Decrease of surface values of pH.
- Decrease of ammonia, N-Kjeldahl y total P concentrations.
- Homogenization of physical and chemical conditions.
- Decrease of relative proportions of bluegreen algae.
- Loss of cyanobacterial “blooms”.
- Increase of relative proportions of green algae.

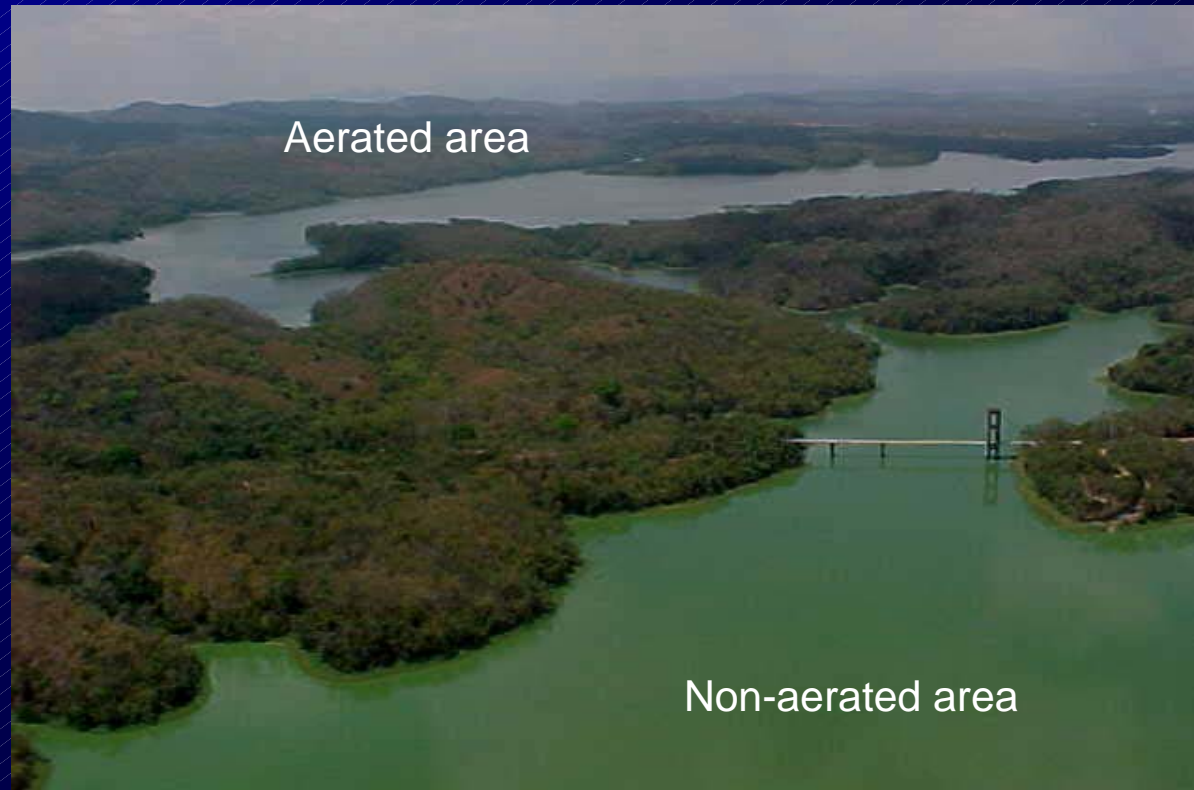
View of “aerated” (above) and “non-aerated” (below) regions of the reservoir
